Condition report

Client: Waddington's
275 King Street East
Toronto, ON, M5A1K2

Two Worcester Hexagonal Vases with Japan pattern

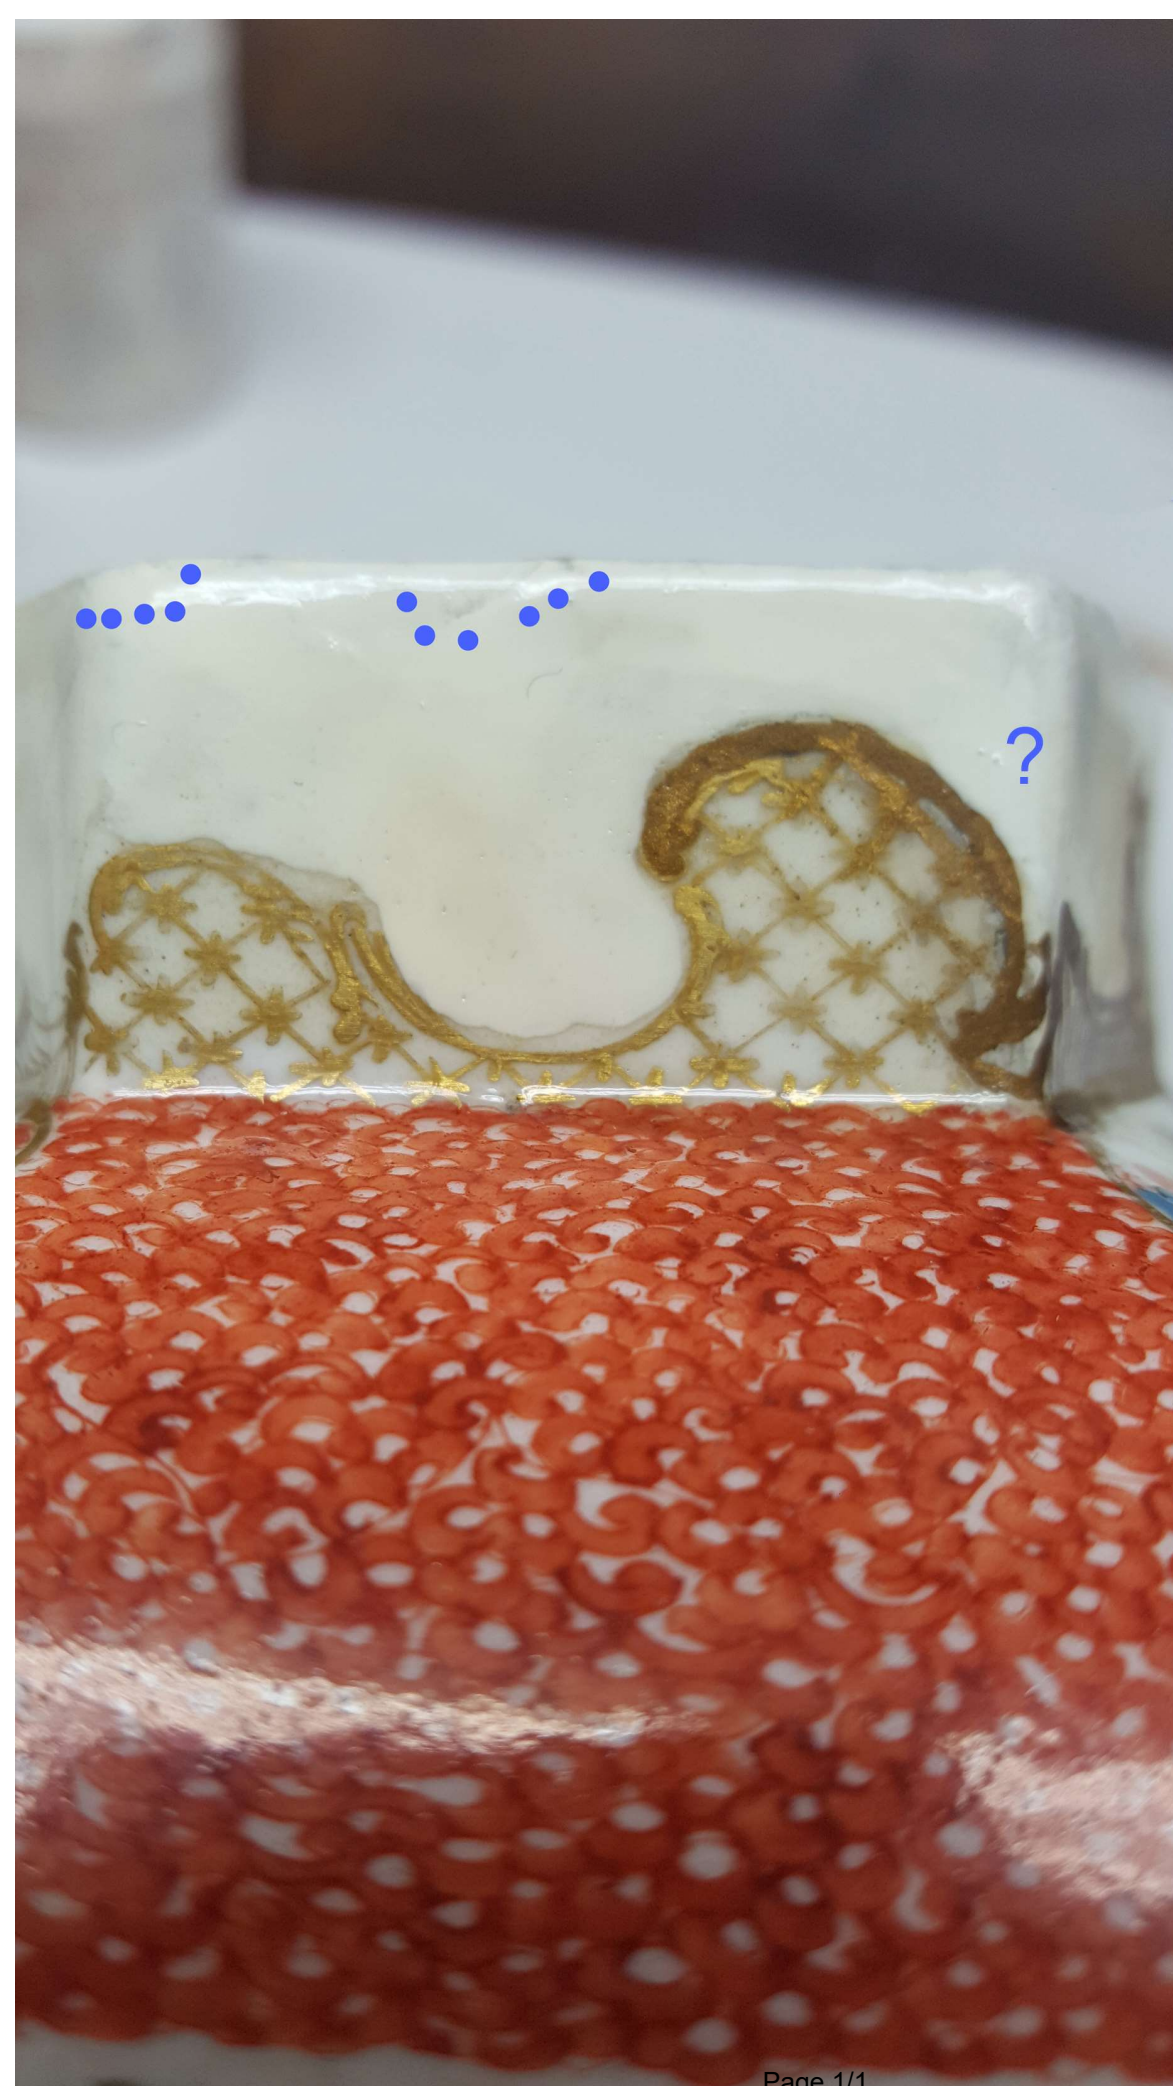
Section 1

gluing continues from
section 6

heavily painted incl.
faux gilding

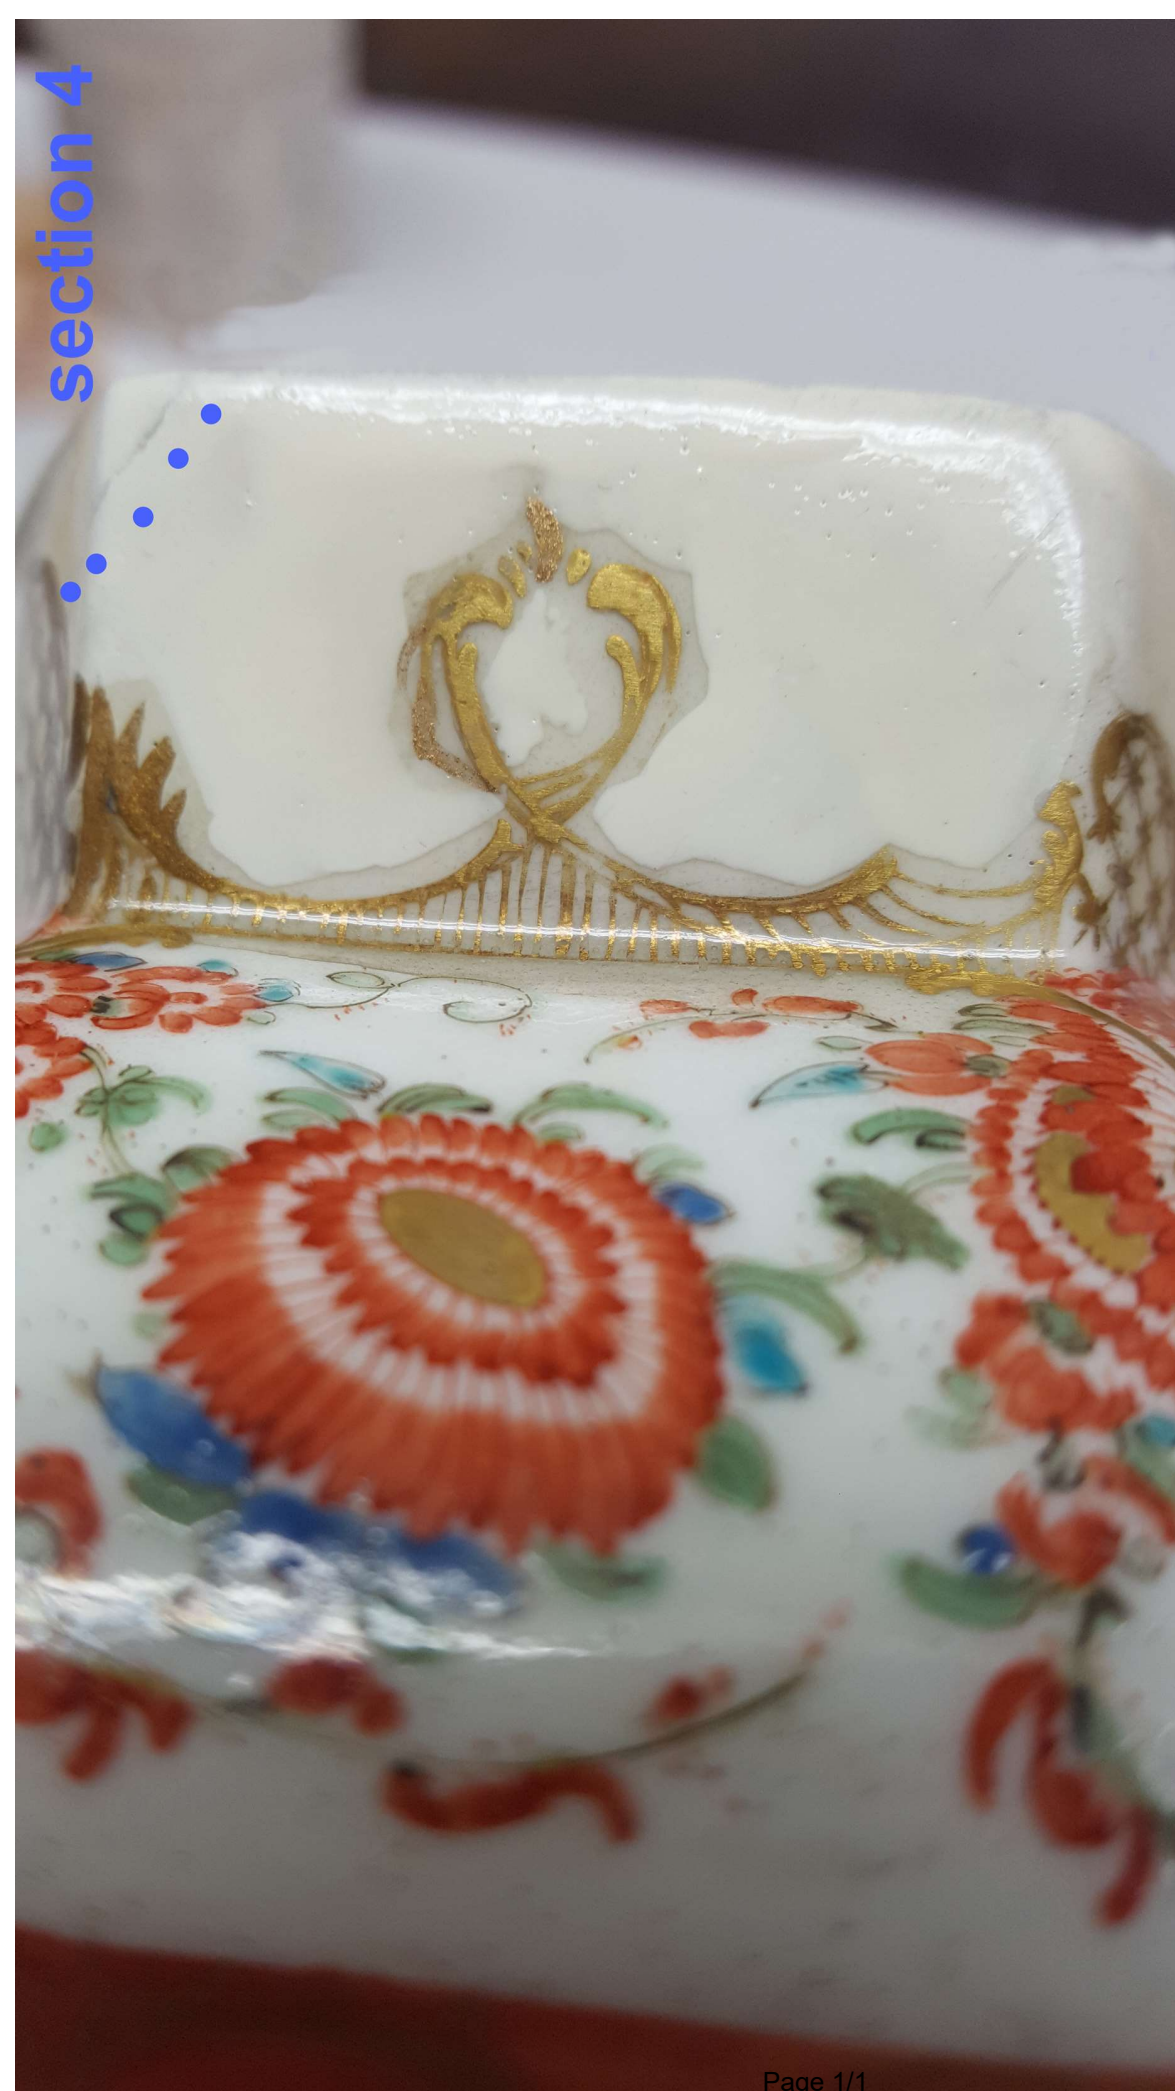
Section 2

chips to rim
maybe damage to right
corner

the gilding is original
except the heavy
outline of the right part,
so no damage in the
lower part of the section

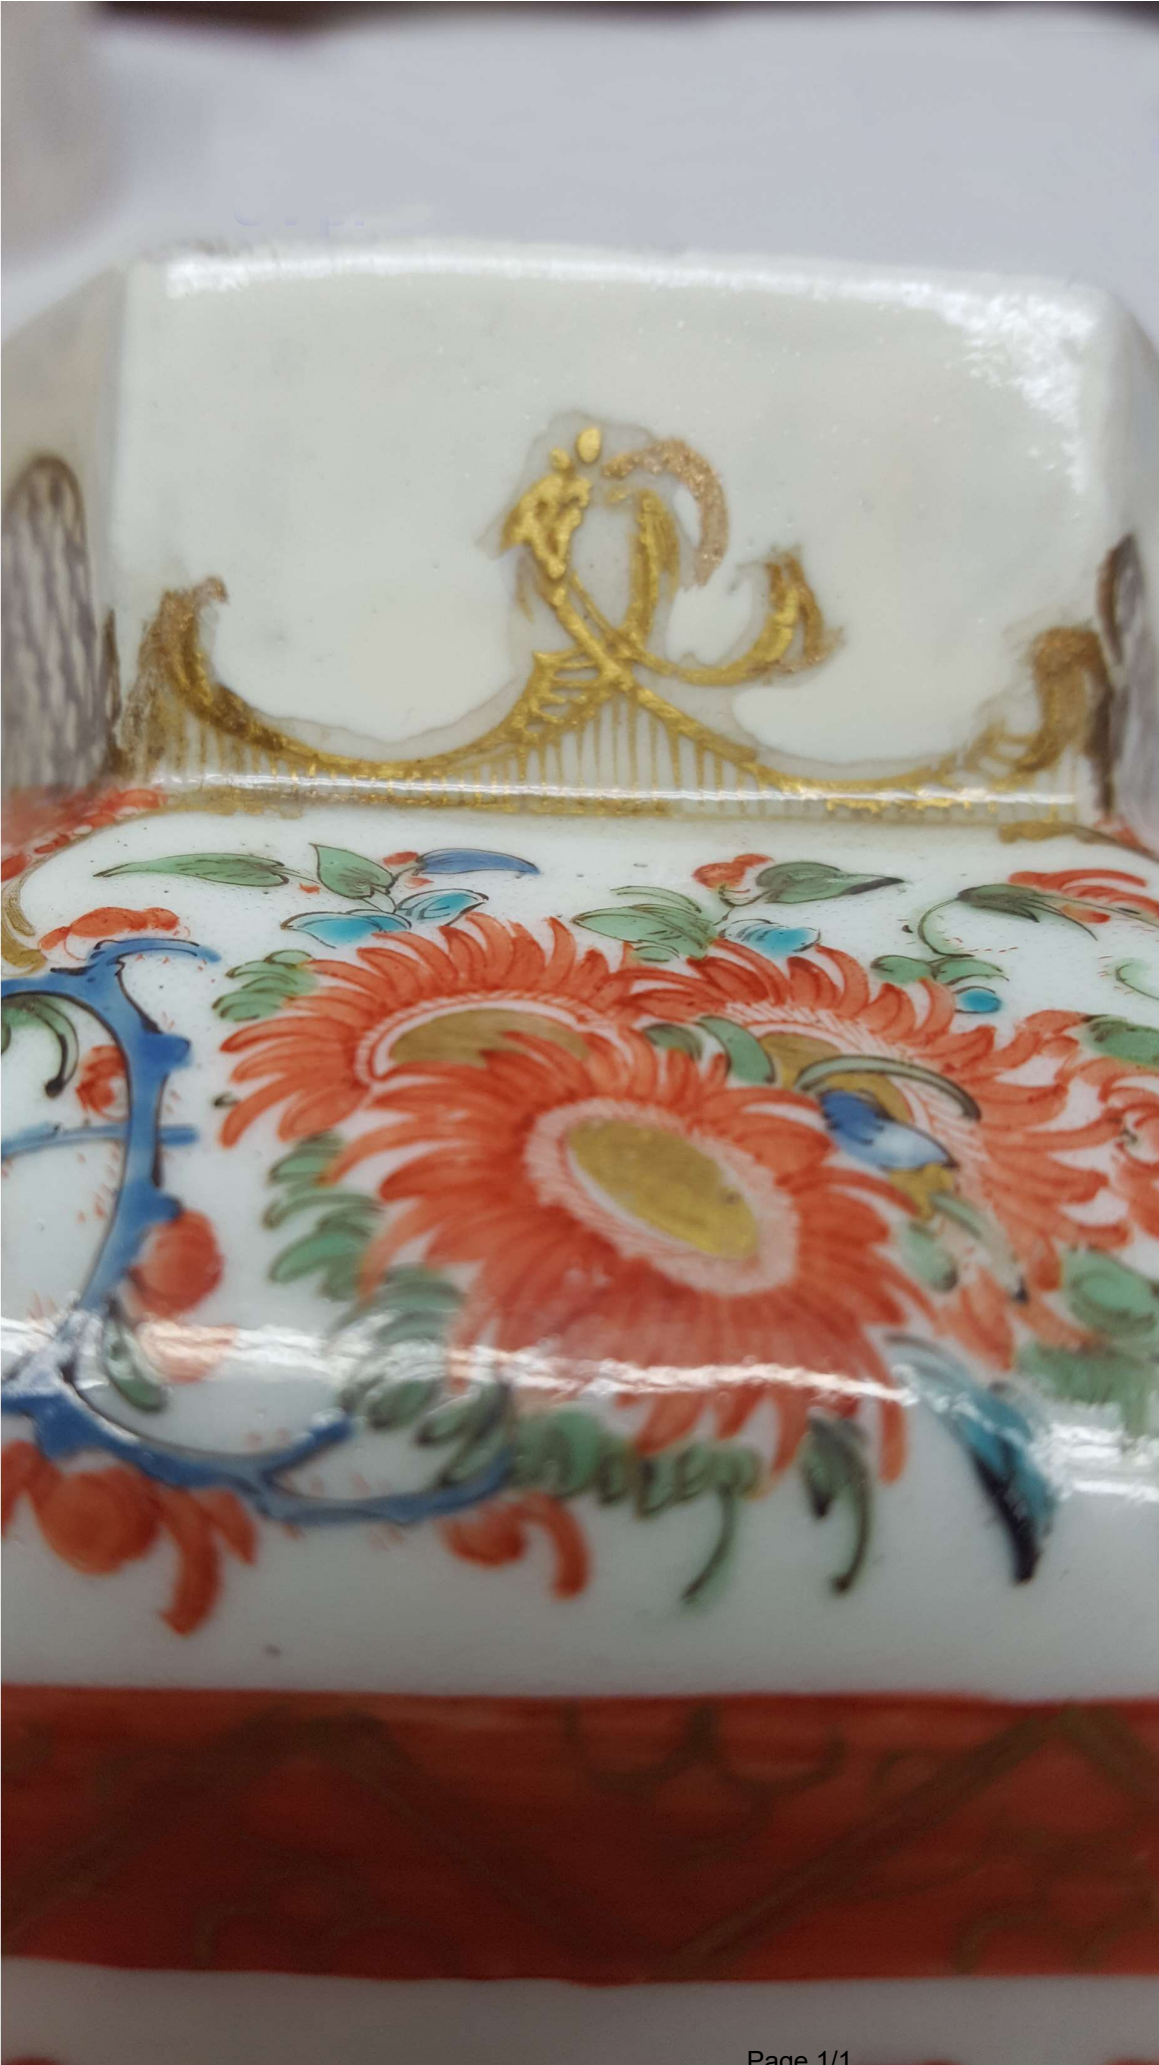
Section 4

gluing: broken part covers most of the section

heavily overpainted incl. gilding

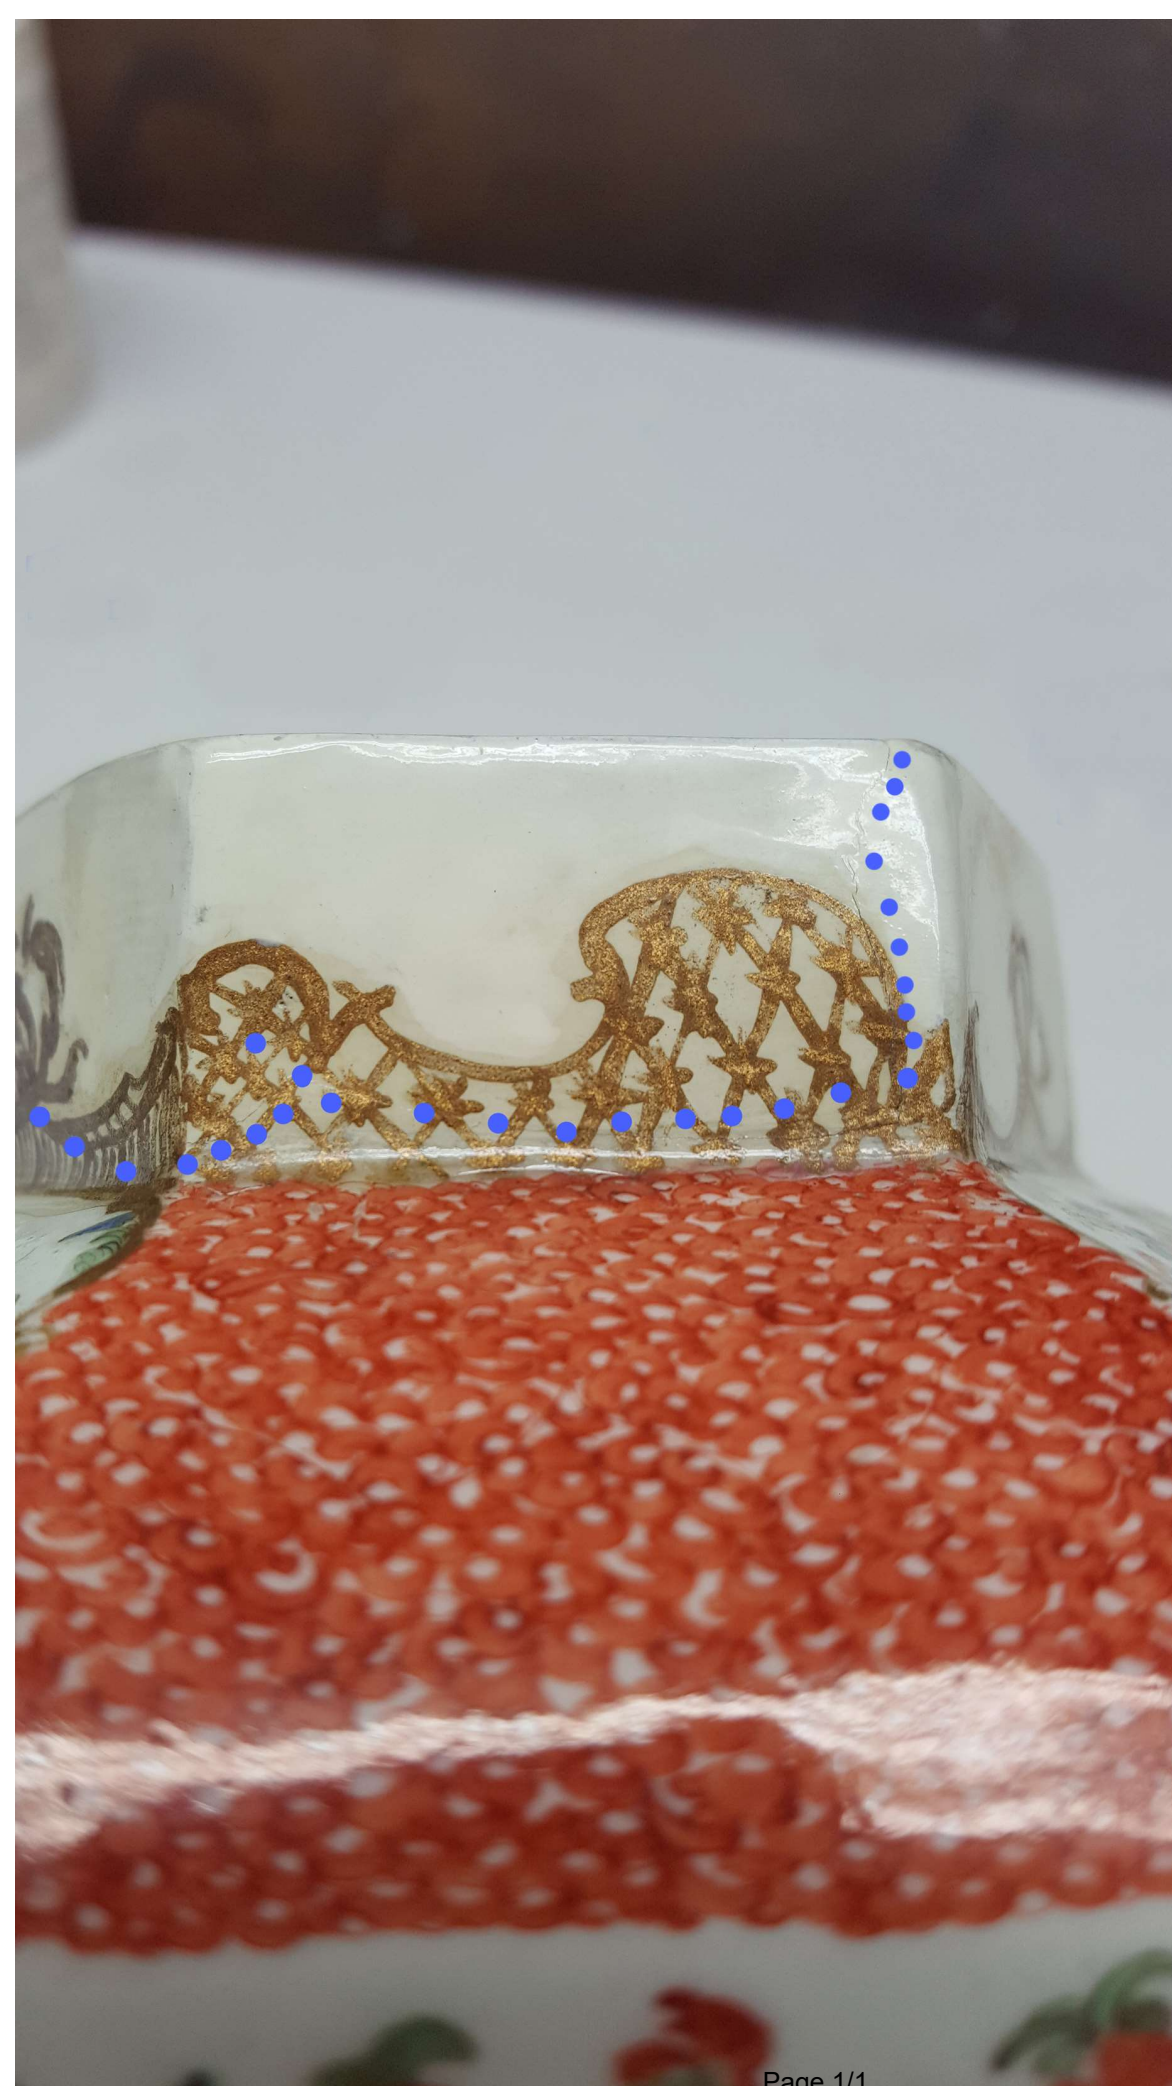
Section 5

possibly just painted over
gilding original except in
corners

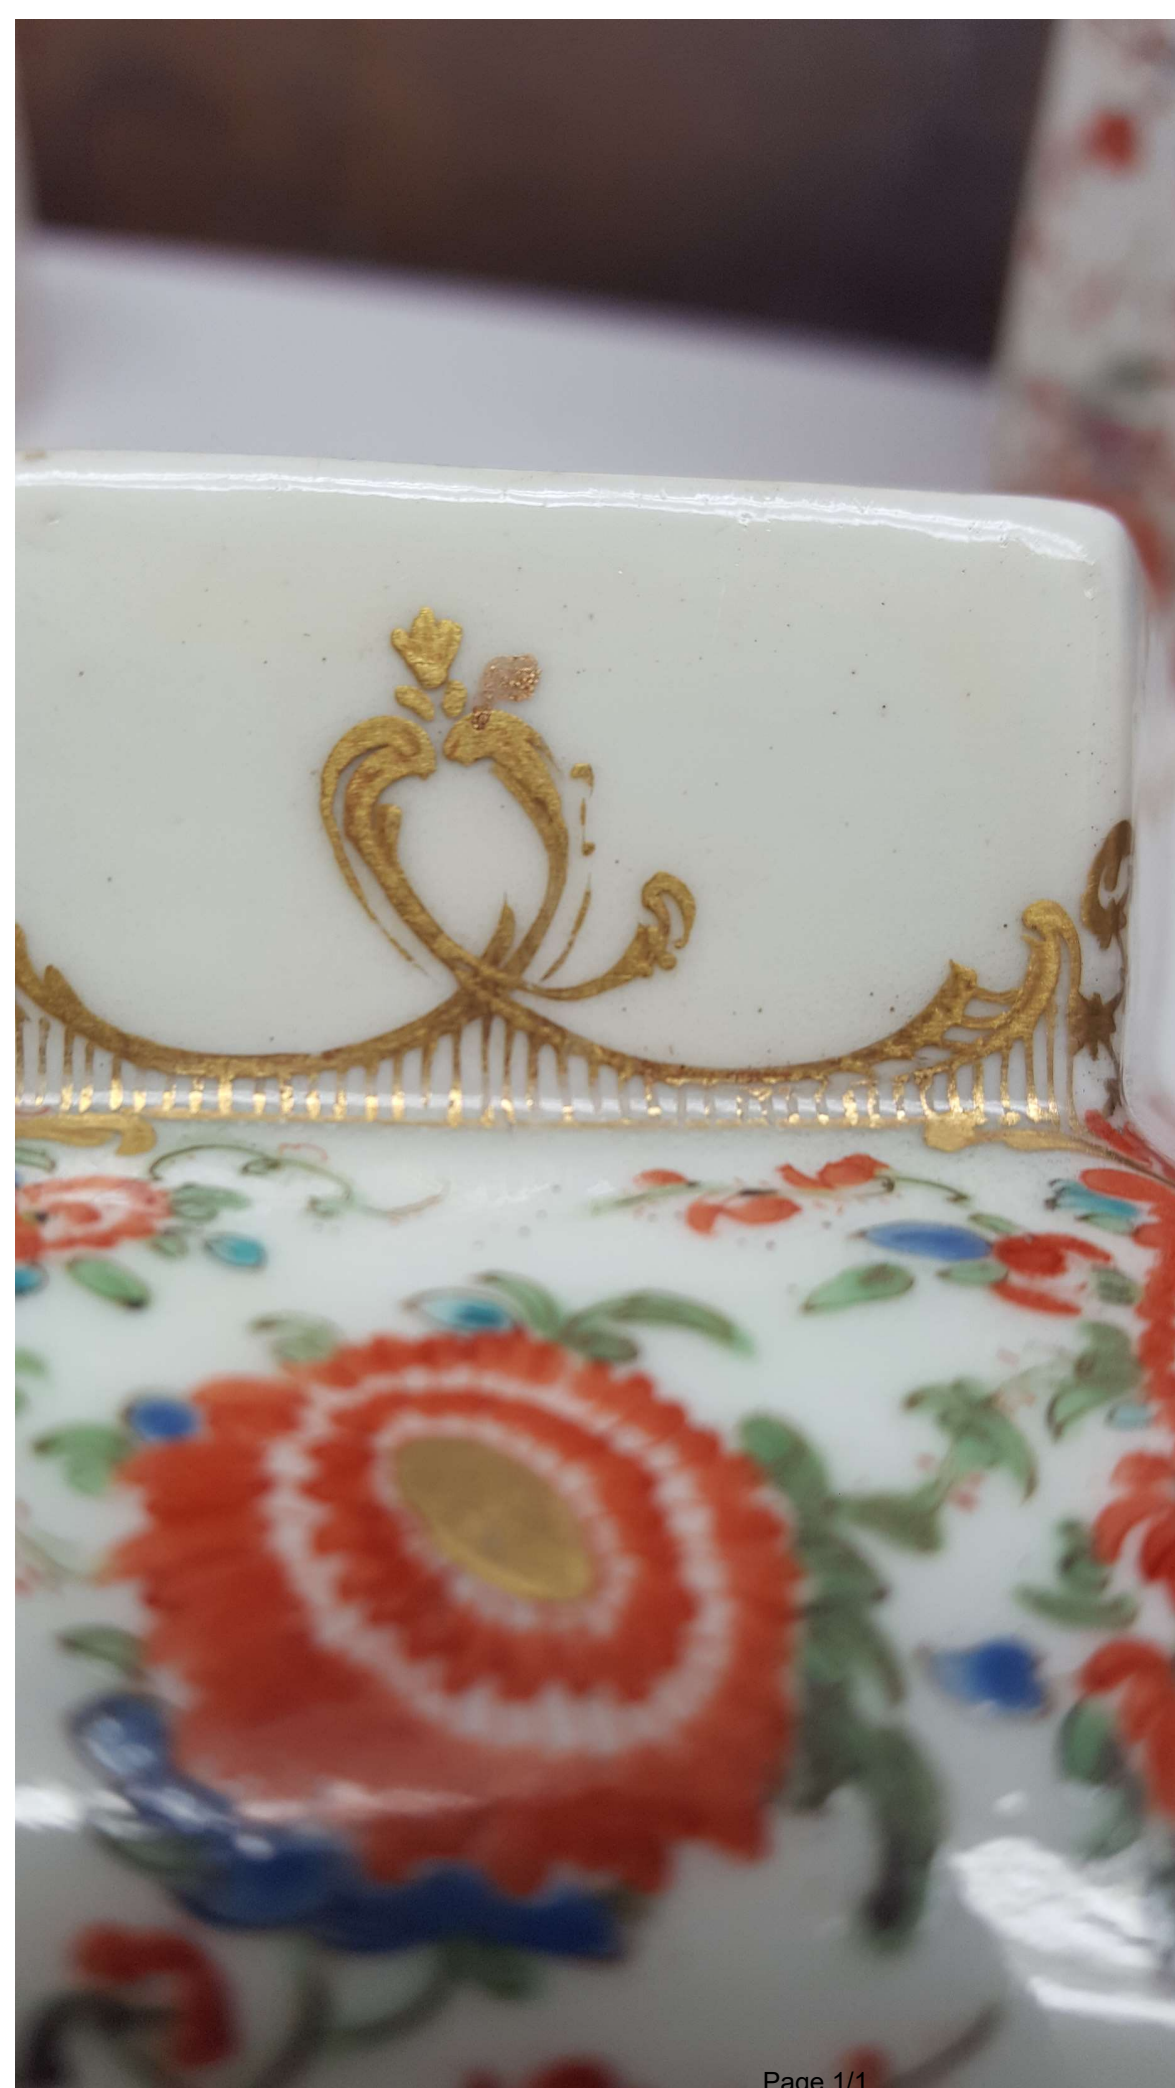
Section 6

gluing:
hard to determine the
start of the line

gilding completely
overpainted

the vertical line may be
a firing crack or a break

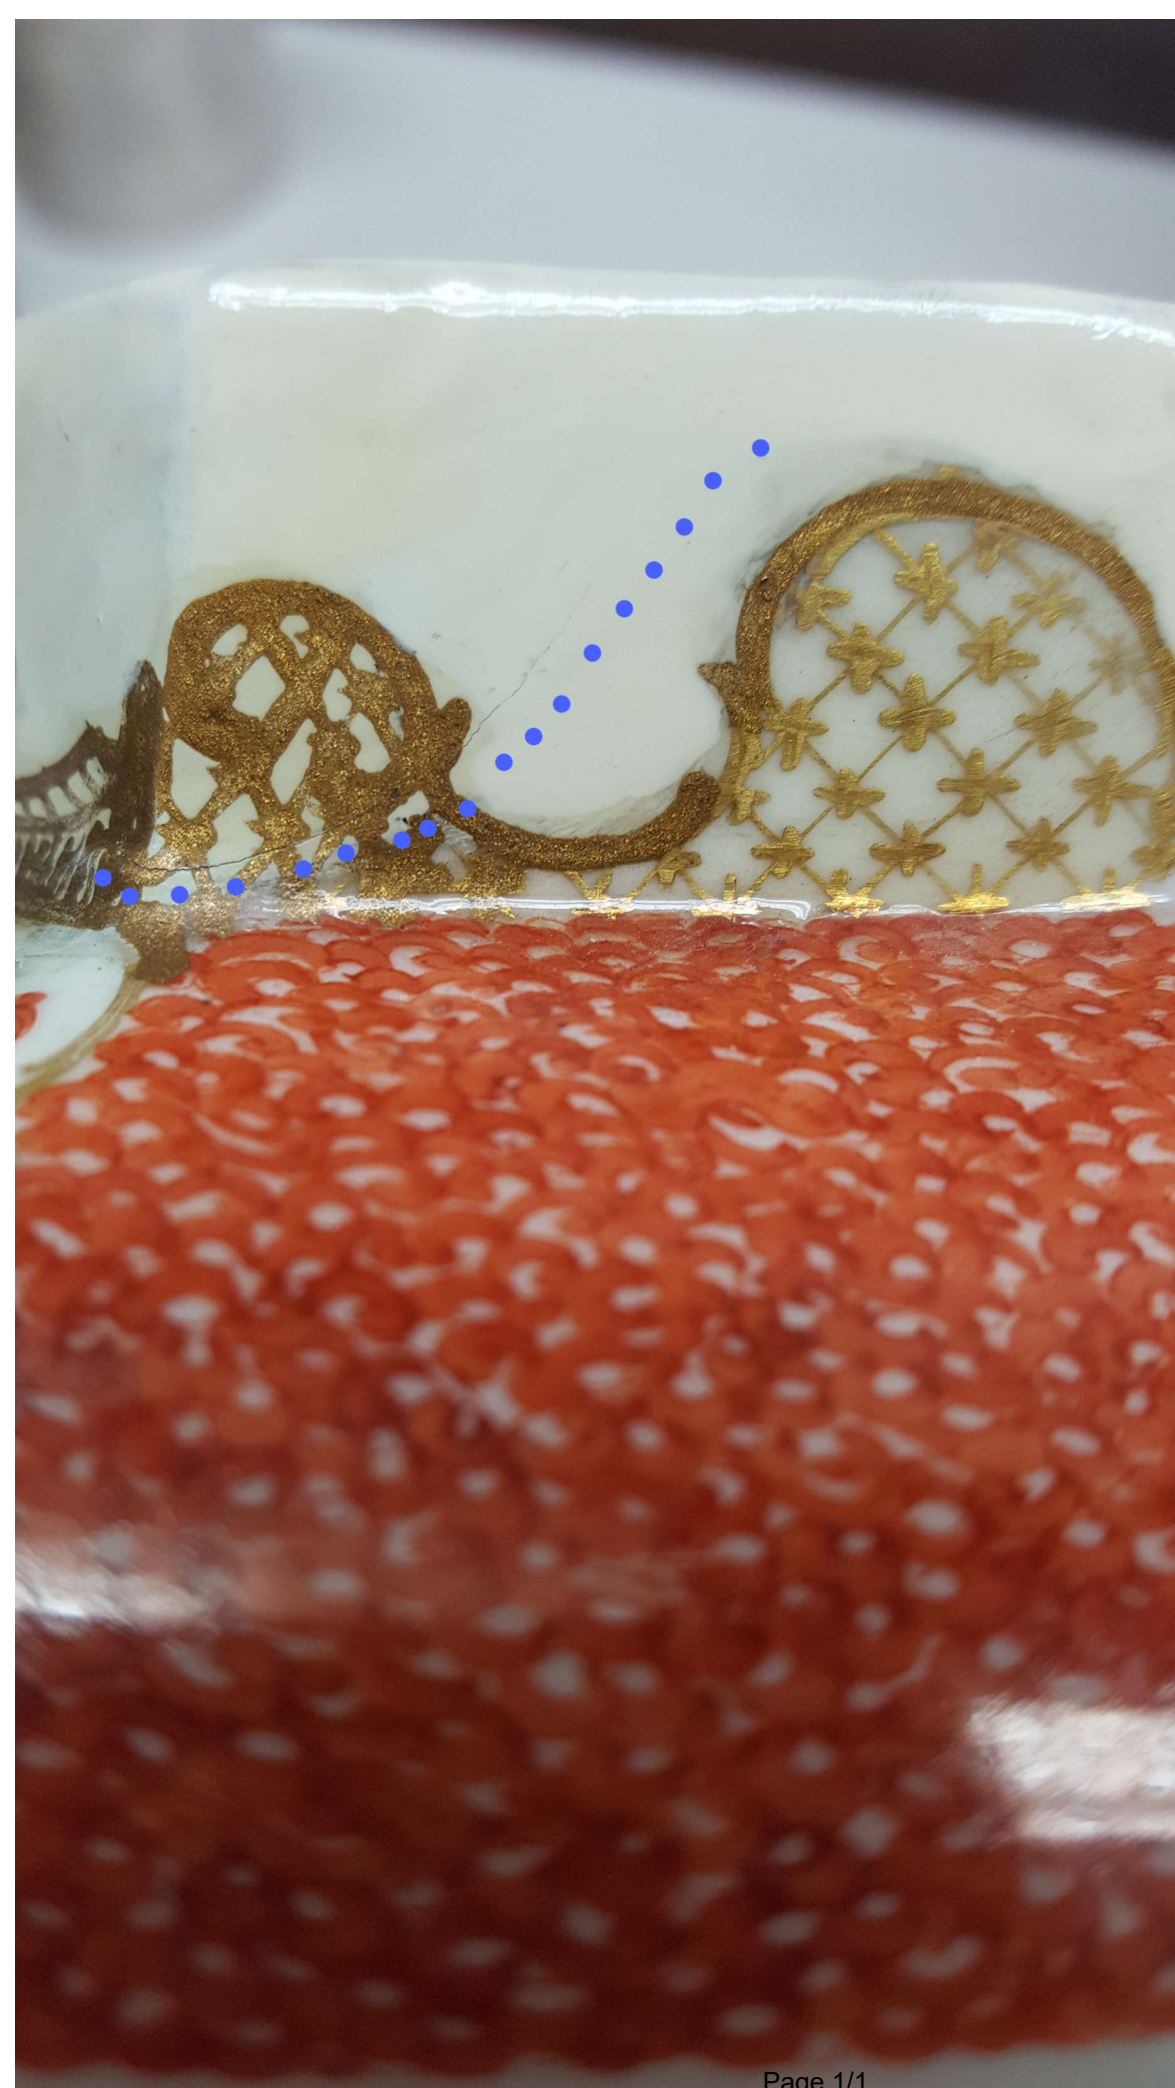
Section 1

in good condition
on the outside,

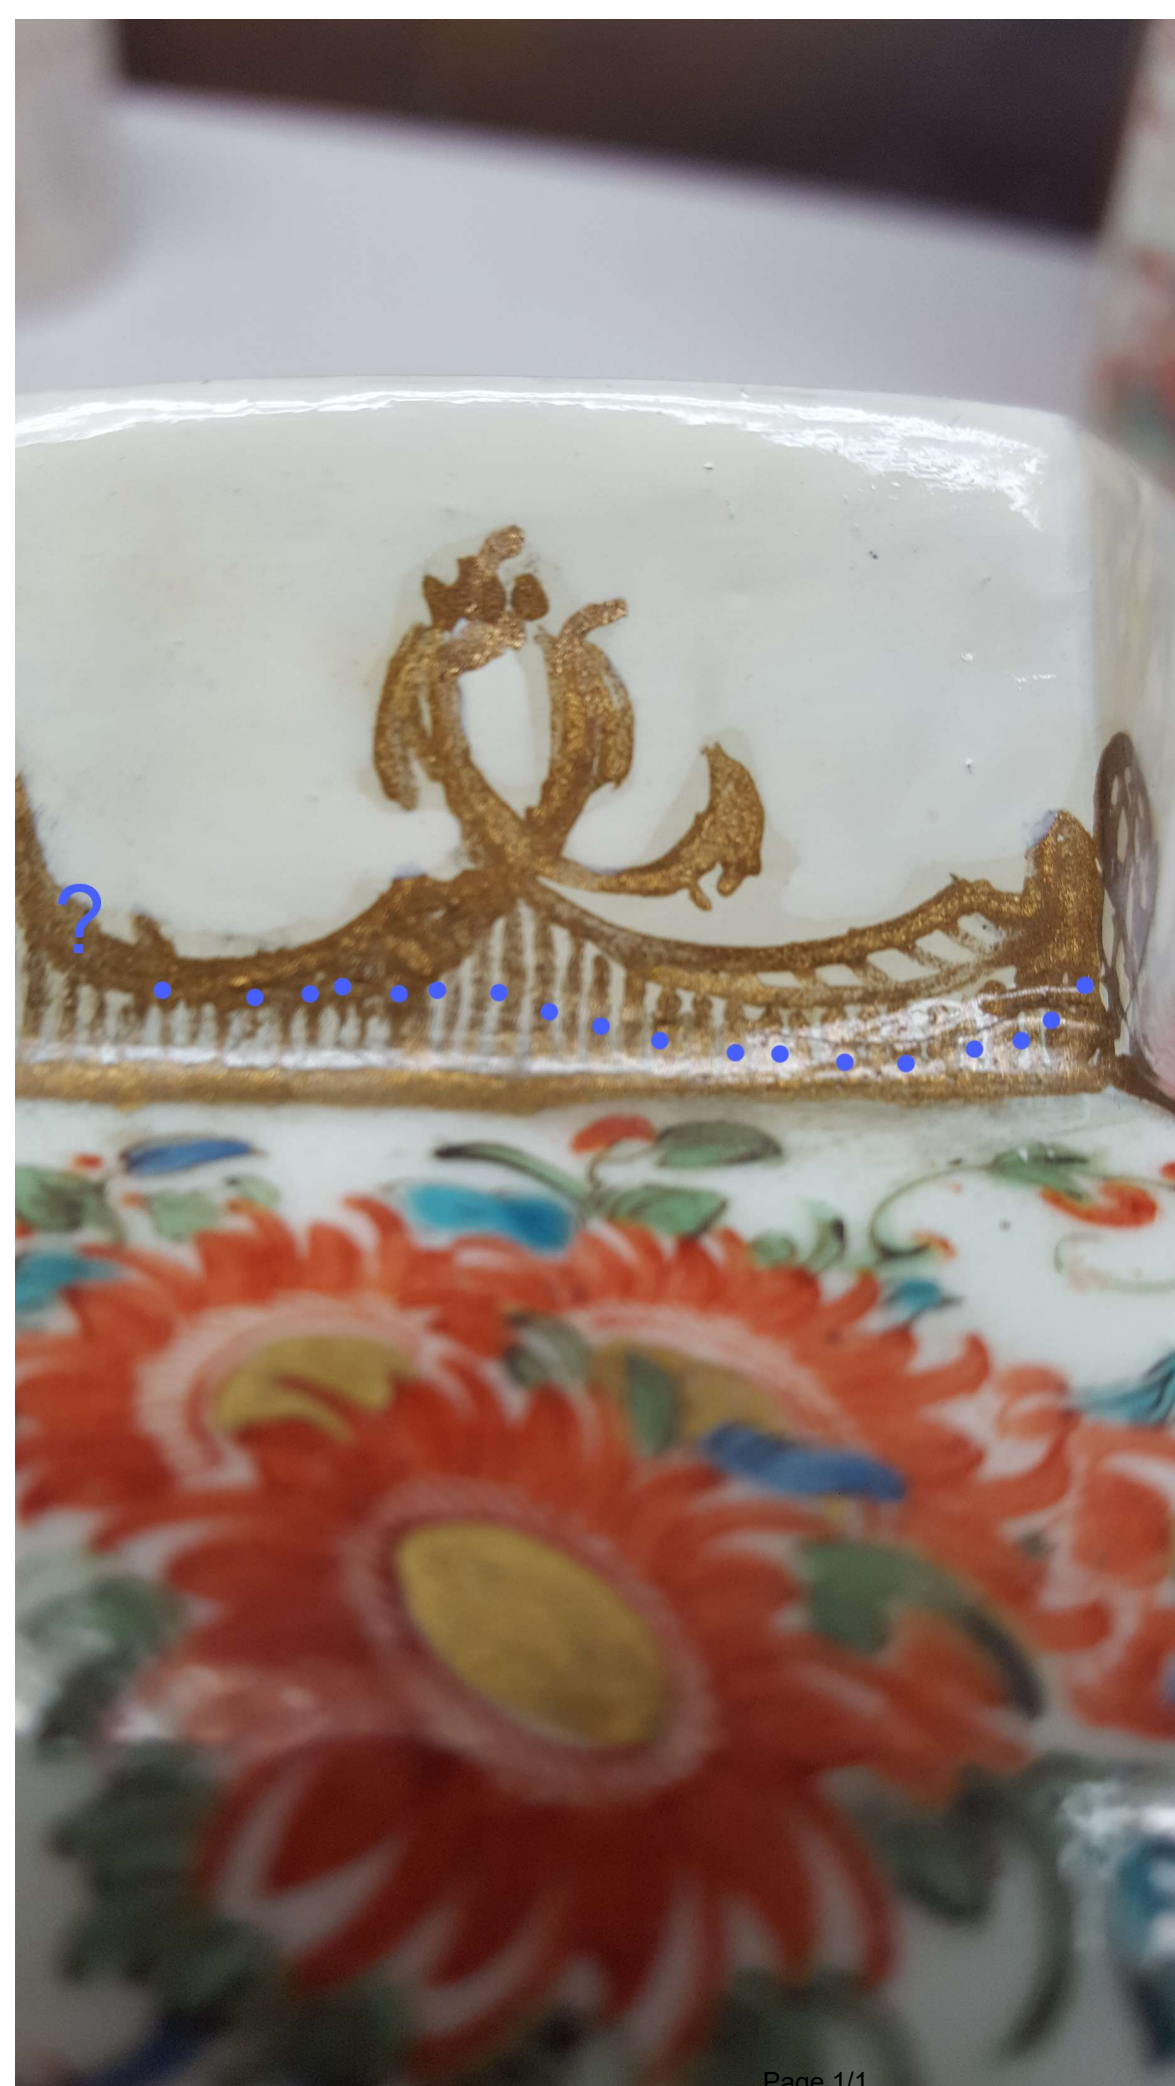
Section 2

gluing along the
dotted line,
heavy overpainting,
esp. gilding

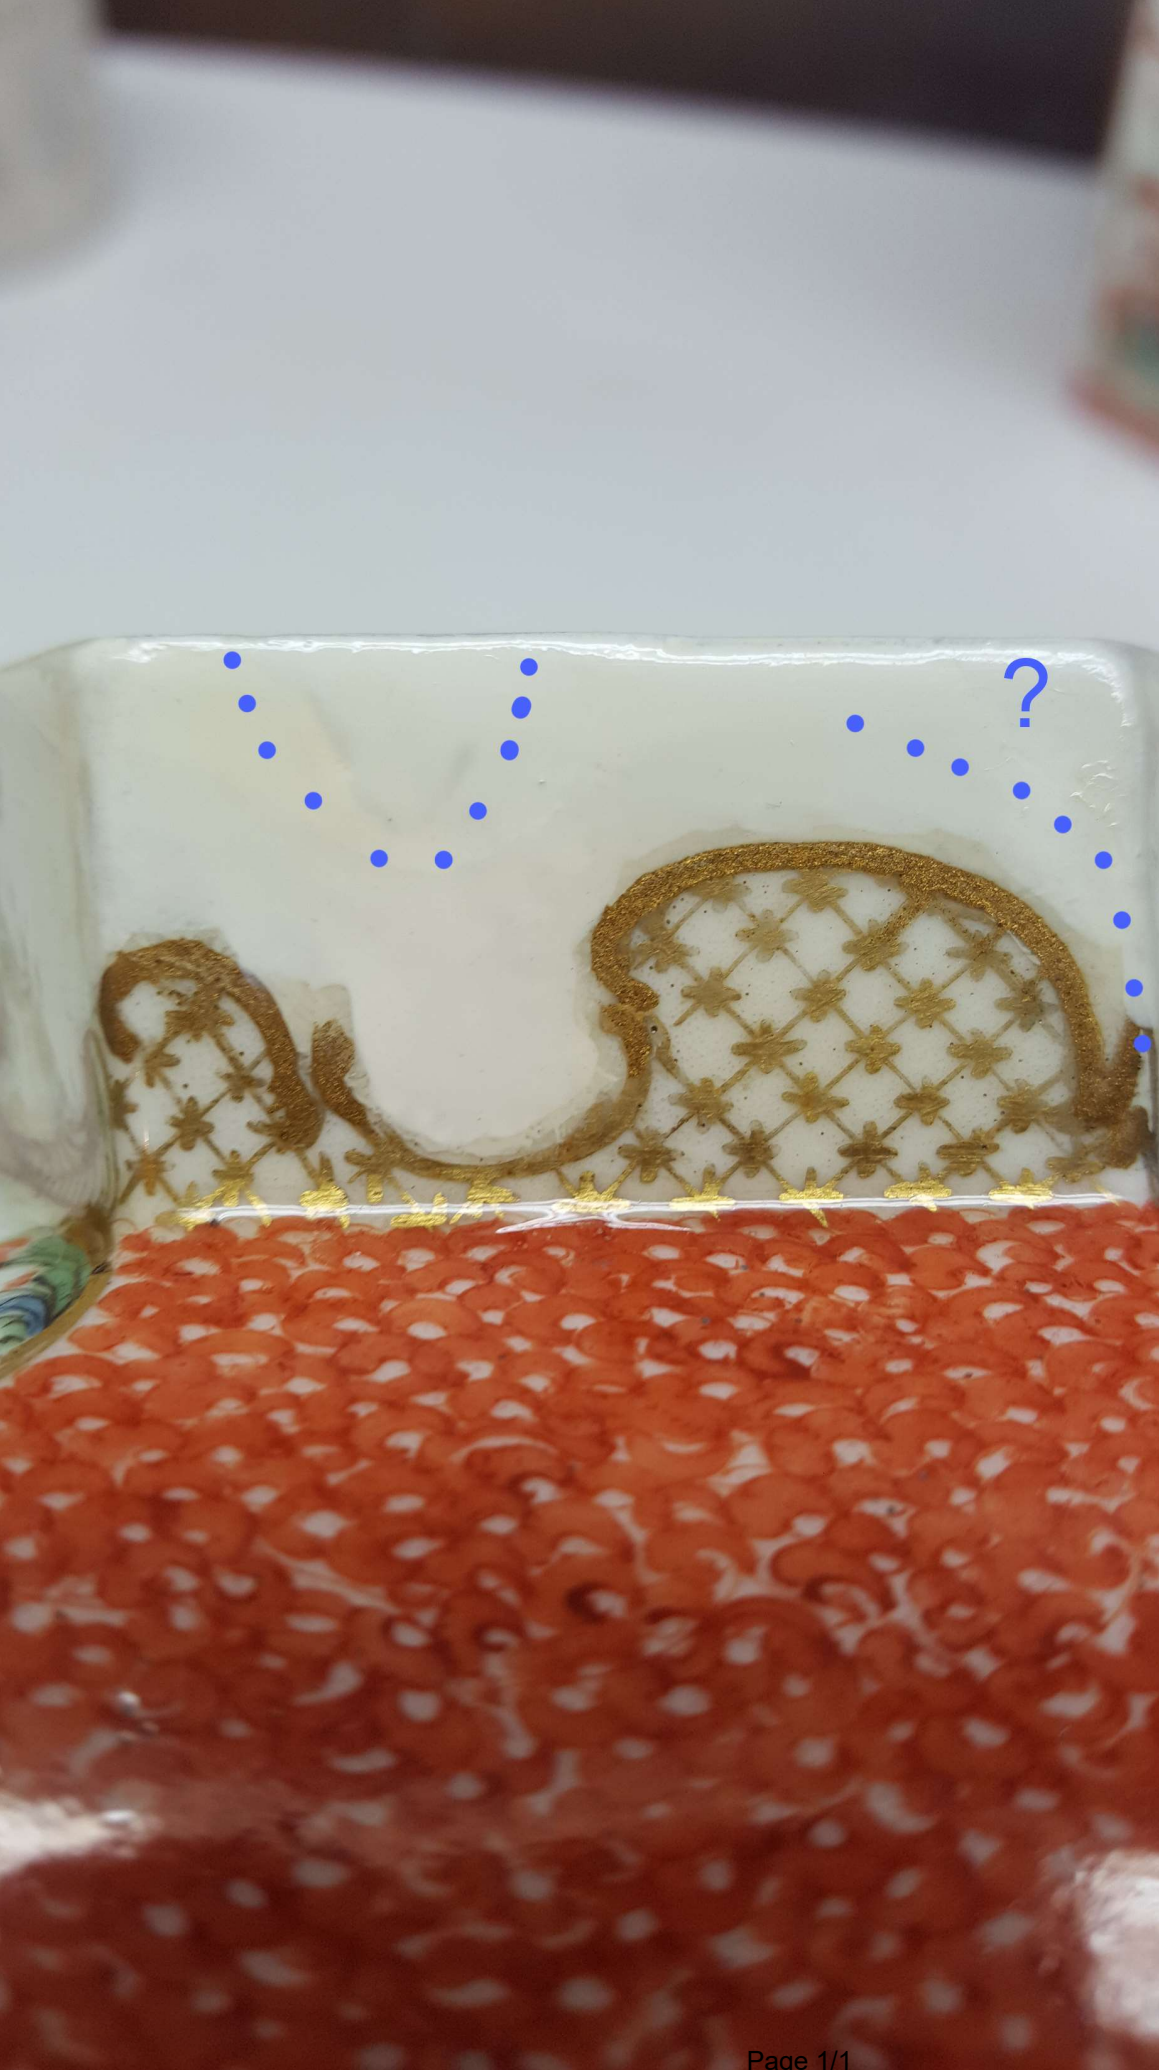
Section 3

gluing along the dotted line (continued from previous section 2)

part of the gilding is painted - possible filling replacement

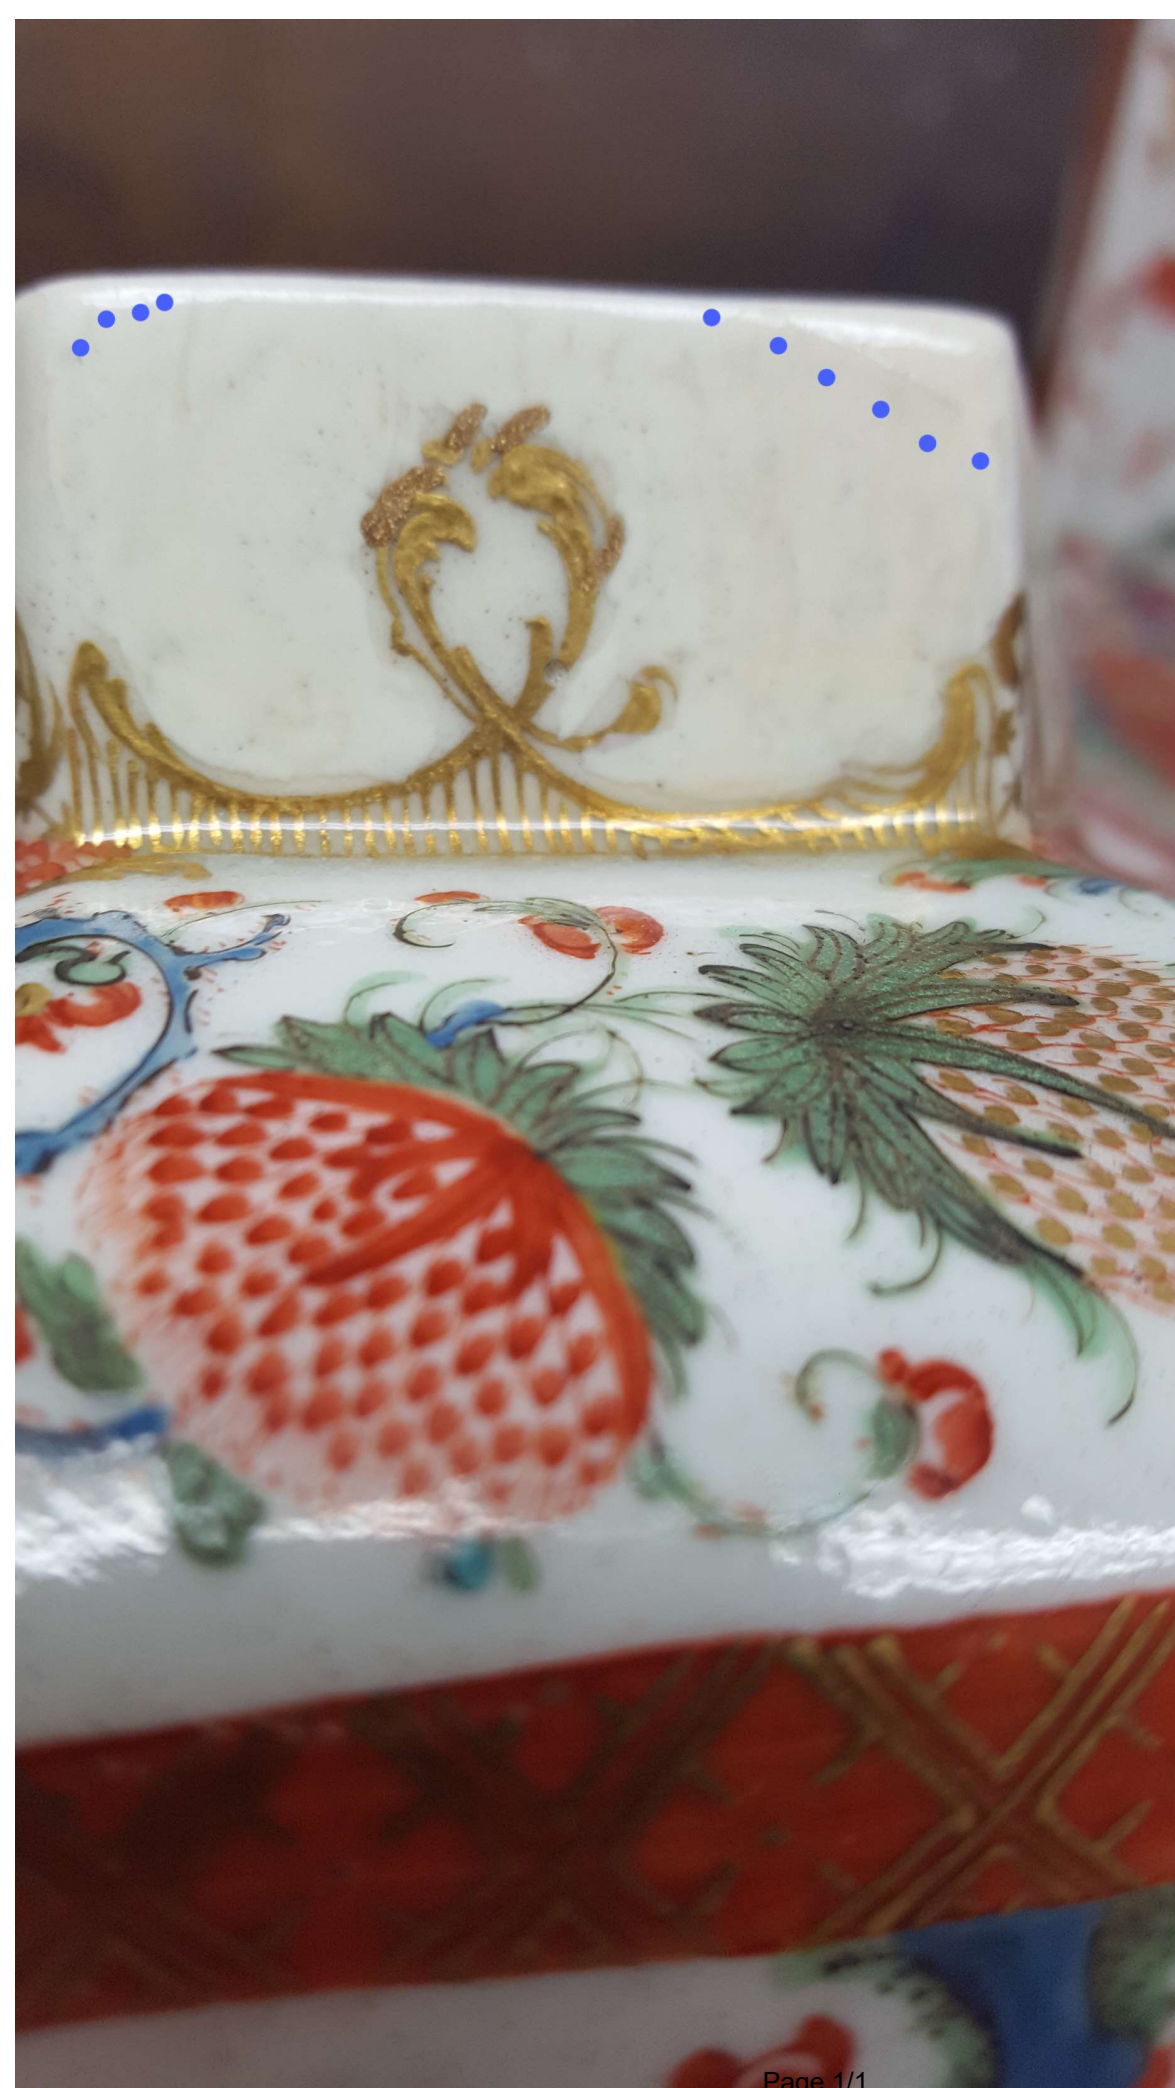
Section 4

chip filling

some restoration in the top right corner as continued from section 3

gilding inside the cartouche designs original, the outline is overpainted.
