Condition report

Client: Waddington's
275 King Street East
Toronto, ON, M5A1K2

Two Worcester Hexagonal Vases with Japan pattern

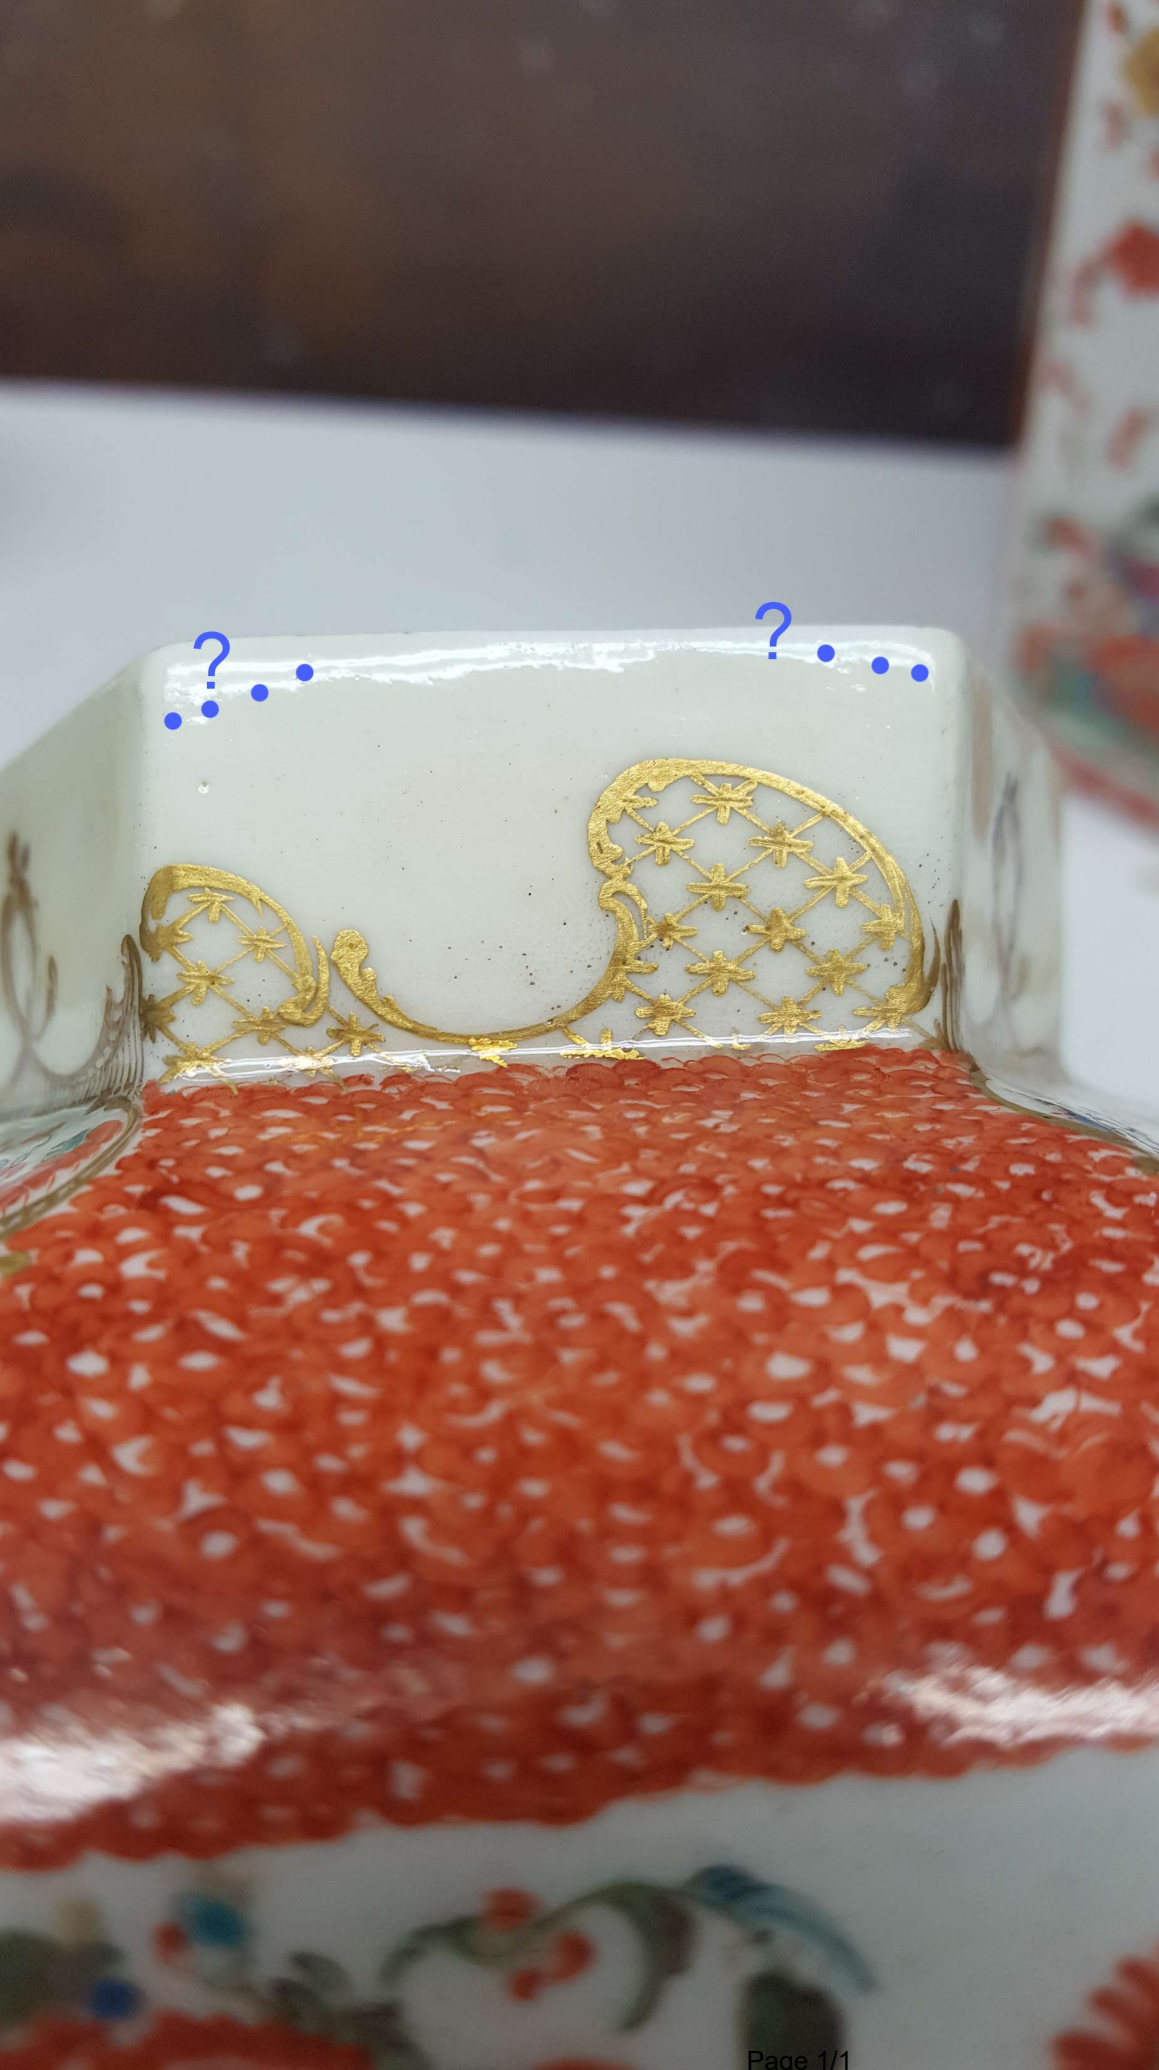
Section 5

Some suspected damage
at left and right top corner

gilding original -
thin overpainting
barely covers the
original grainy glaze
